HOME INSPECTION REPORT

Prepared By:
Valued Home Inspectors
226--88th Street
Brooklyn, NY 11209

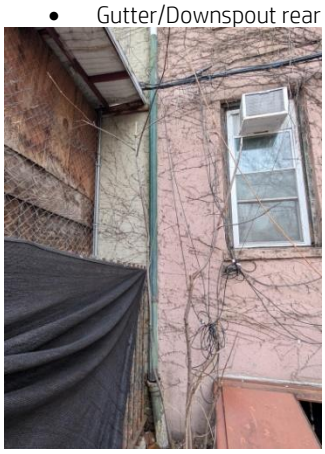
- Gutter/Downspout rear is old (Monitor)—did not see anything exposed thru

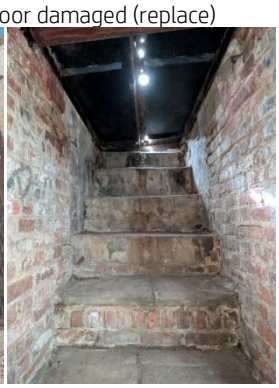
- Front basement door damaged (replace)

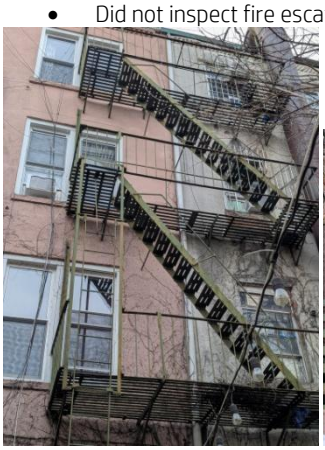
- Did not inspect fire escape but there are rusty areas (recommend scrape and/or paint) as general maintenance

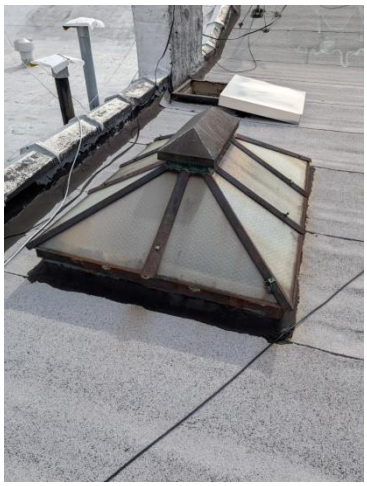
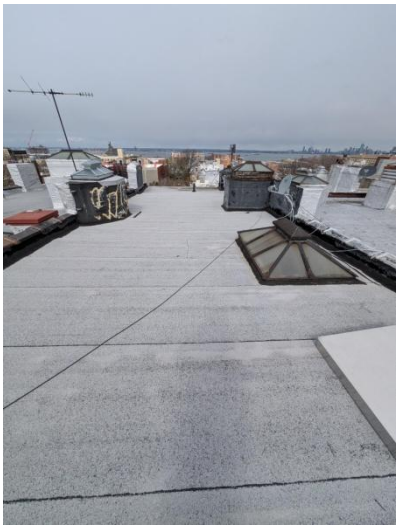
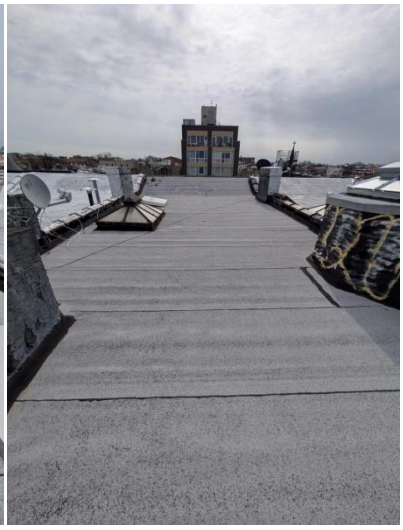
- Roof:

1. Surface intact (no damage..sagging soft areas or exposed areas)
2. Skylights and Vent are older/rusty and older flashing and can allow water entry (re-seal/flash) where needed ... This includes covering over the chimney

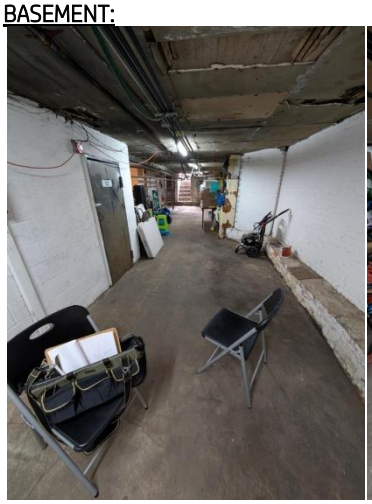
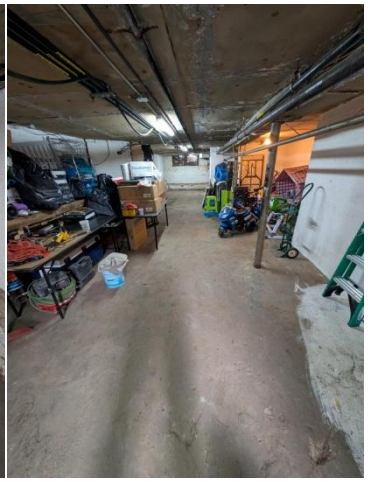
BASEMENT:

- Wood steps are older (still intact / no loose steps were present)

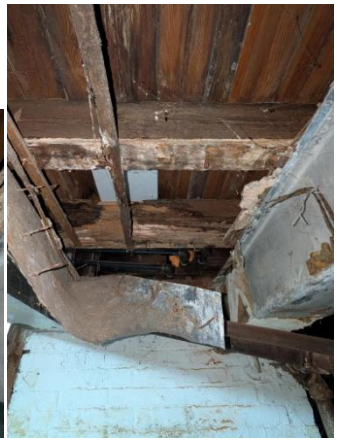
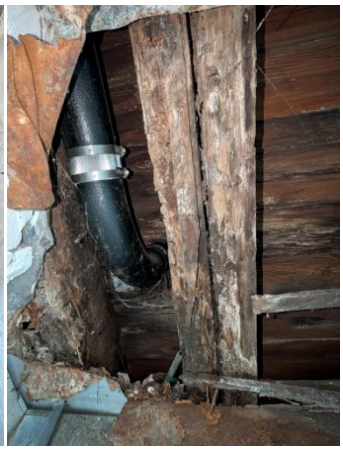
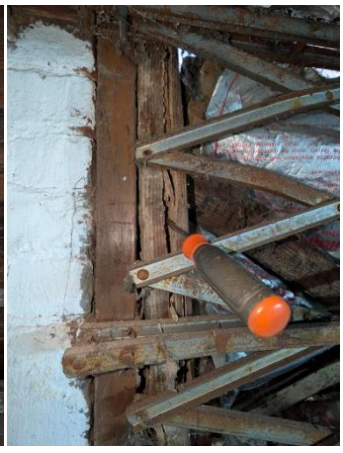
<u>Rear:</u>

1. Multiple joists have past termite damage and need to be evaluated further for added support needed
2. End connection of main beam also has some past termite evidence although when probed screwdriver did not penetrate thru the visible area as it did on joists...

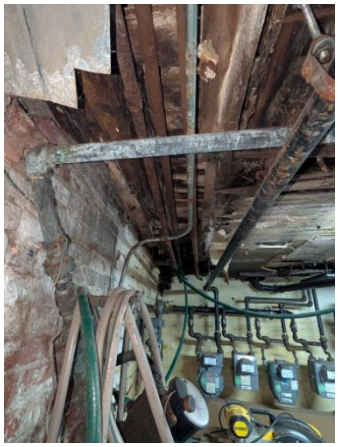
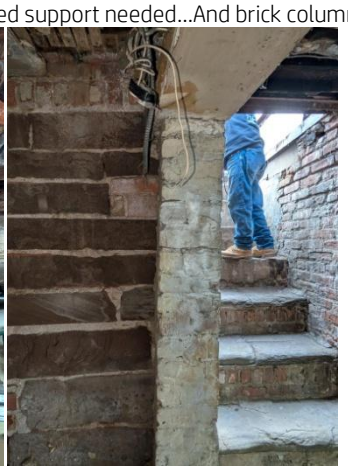
Front:

1. Not a lot visible but you can see joists do slope down from both side directions…You would need to expose ceiling in this area to evaluate further for added support needed…And brick column is slanted/past settlement

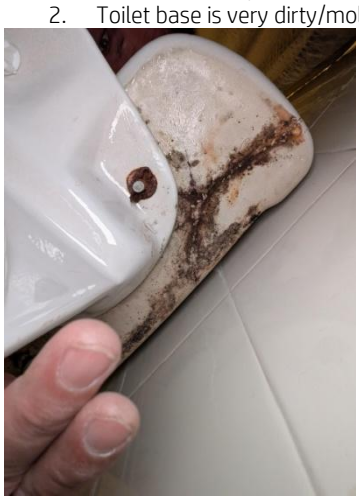
1. Sink cabinet very old
2. Toilet base is very dirty/moldy (looks like crack is forming and starting to drip)—recommend clean area

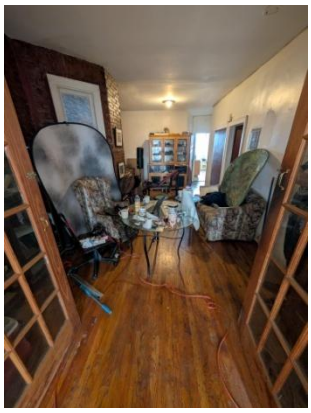
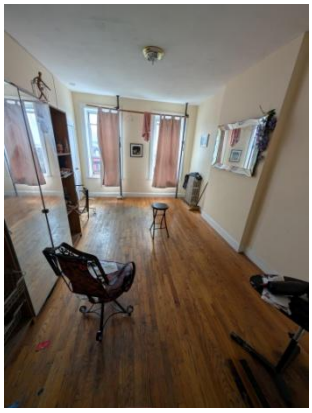
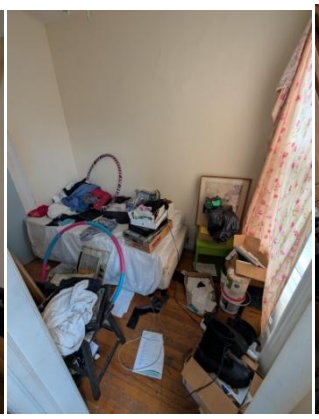
LEVEL 4 APT:

- No heat source present in middle room section
- Windows are older style but they are working properly (a few locks did not line up fully to lock them)...And no leaks were present
- Walls-Ceilings have some cracks and/or loose peeling paint present...No stains or soft areas were present. They all appear to be old/cosmetic cracks...

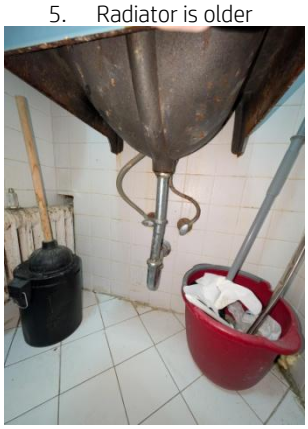
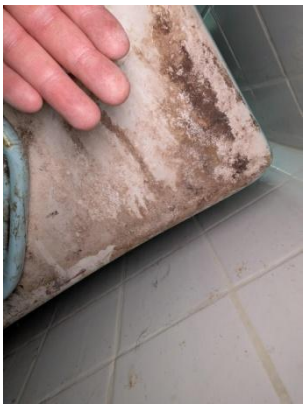
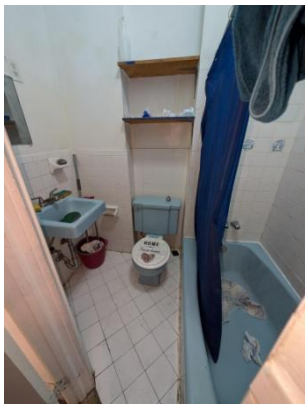
- Bathroom (older)

1. Sink is very old and rusted
2. Toilet base is very dirty/moldy (no leak was present)—recommend clean area
3. Caulking needed around tub area and around wall tiles (some were bowing out a little)
4. Replace outlet with gfci outlet for safety around water
5. Radiator is older

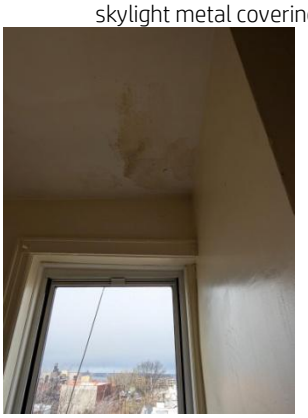
- Kitchen: (is old)

1. Everything here is old (Oven dirty/greasy)—needs cleaning or replacement
2. Moisture stain above window…Recommend paint and Monitor. Gutter did not look damaged or backed up, however also on roof is old skylight metal covering rusted and old flashing and water could also enter in from this area…

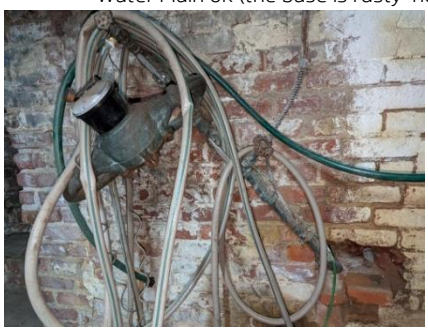
- Water Main ok (the base is rusty-not leaking)…Maybe try cleaning this area of rust

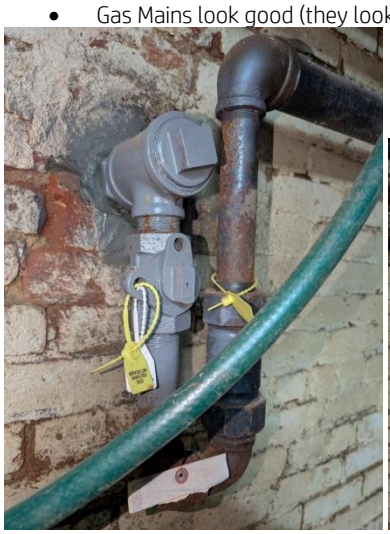
- Gas Mains look good (they look like newer gas piping)

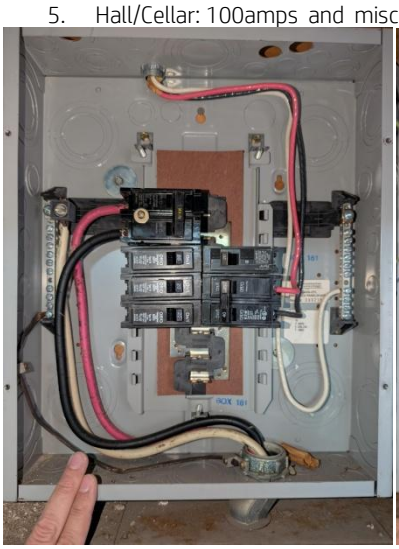
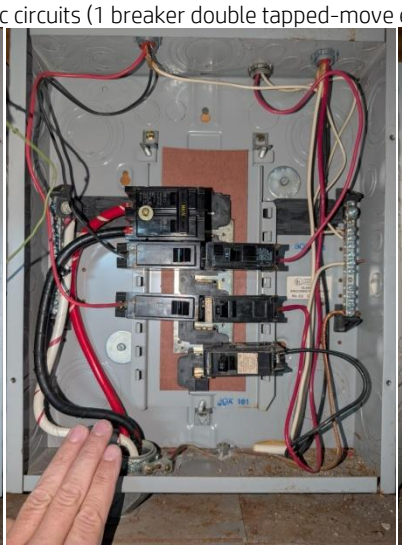
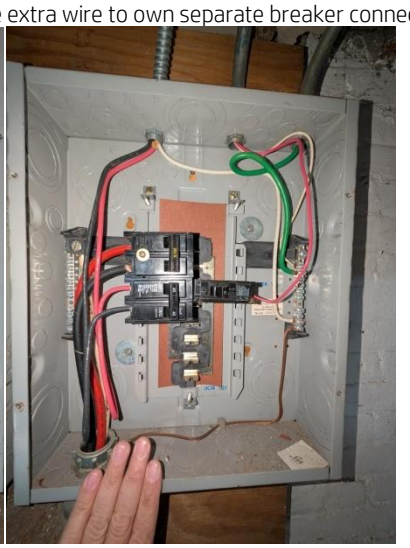
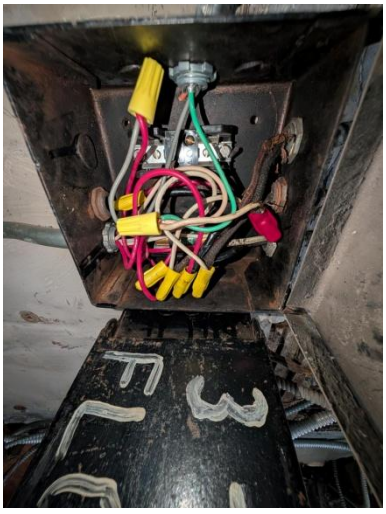
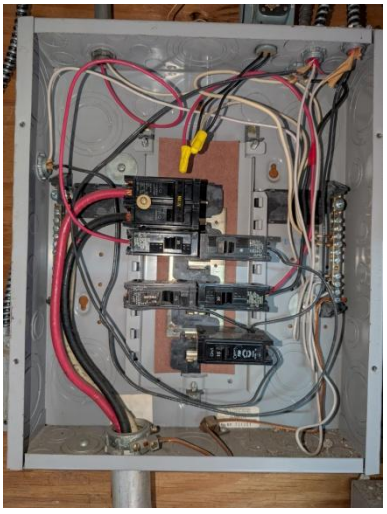
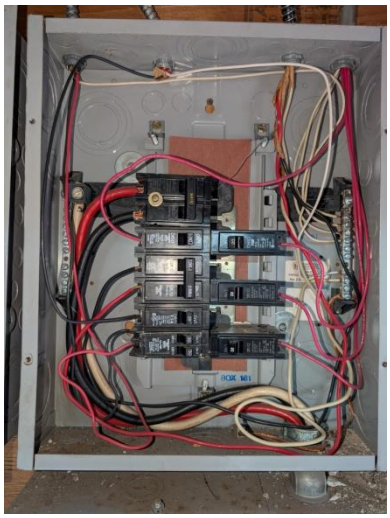
Main Panels:

1. 4th floor: 100amps 1-40amp 1-15amp
2. 3rd floor: 100amps and misc circuits
3. 2nd floor: 100amps and 1-40amp…Rest breakers nothing connected
4. Store: 100amps and misc circuits…30amp breakers appear to have 12awg wiring that should connect to 20amp breakers/not 30amp.
5. Hall/Cellar: 100amps and misc circuits (1 breaker double tapped-move extra wire to own separate breaker connection)
