HOME INSPECTION REPORT

Prepared By:
Valued Home Inspectors
226--88th Street
Brooklyn, NY 11209
718-232-1776 / 917-589-7310
Report Number:

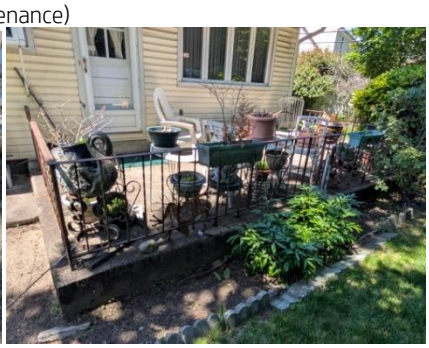
- Deck:

1. Surface crack in concrete ground (and) 2 outer corners…No movement present (seal to prevent any further damage)
2. Rails are rusty (need some maintenance)

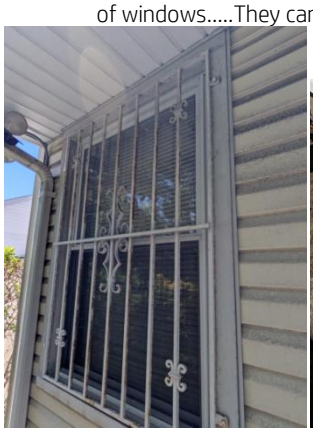
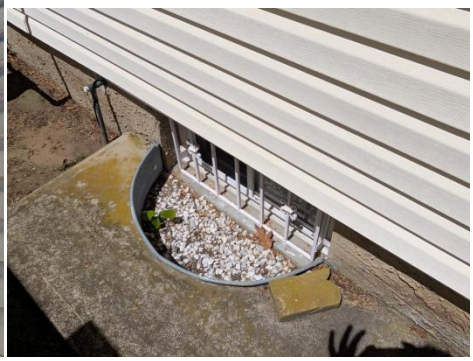
- Windows:

1. Security bars rear corner are rusty (needs some maintenance)…Also, in all rooms with bars on windows “it is recommended to have bars that swing open in case emergency exit is ever needed”.
2. Window wells present (some are covered)….Did not see any ground drains in the dirt . No water stains/leaking present interior areas of windows…..They can all be covered over during times of heavy rain

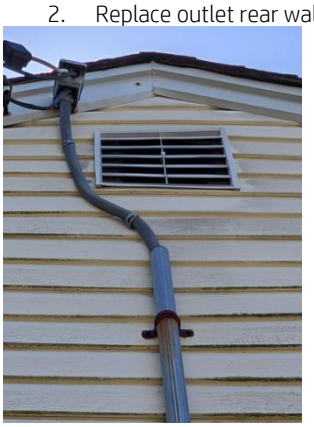
- Electric:

1. Top portion of main wires is not covered/protected inside metal conduit like the rest of it (Recommended)
2. Replace outlet rear wall with gfci outlet for safety around water

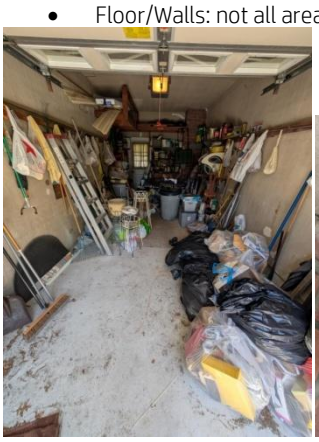
- Floor/Walls: not all areas visible “cluttered w/debris”…Right side wall base areas of concrete plaster finish is coming loose.

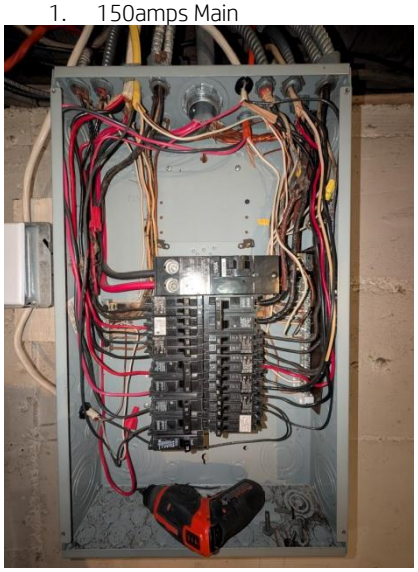
1. 150amps Main

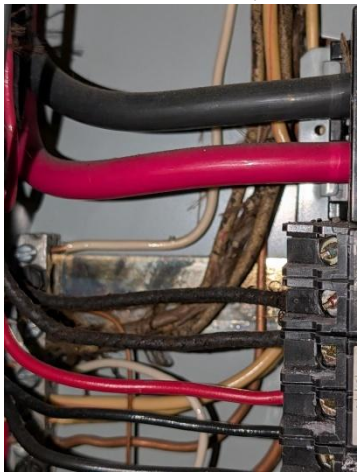
2. There are some older cloth wire circuits present and some 2 prong visible 1st floor (replace all with 3 prong)...Here is some notes on cloth wiring:

Cloth Wiring (or cloth sheathing/covering over wire) is older style insulation. It can be more brittle than updated Plastic wire sheathing.. It is Less heat resistant and possibly some older/outdated aluminum wire and 2 Prong Outlets might also be used on these circuits…If left alone inside metal BX cabling should be fine. If working on any electrical items (Ex: Replacing outlets / Installing ceiling fan / etc…). Check first if older cloth wiring present on that circuit, and if so work gently so you do not expose any wires. You can always consult with a Licensed electrician for further scope of work needed if ever looking to replace the cloth with updated "Plastic Style" wire sheathing.

3. Label all circuits "know everything connected to each circuit"

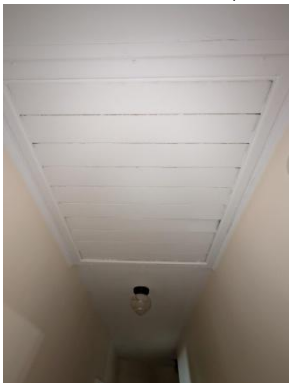
- There is a large attic fan operated via wall switch…When turned on it was very loud and the flaps did not open up on ceiling cover (evaluate further)….

1. No attic hatch / accessibility was visible anywhere

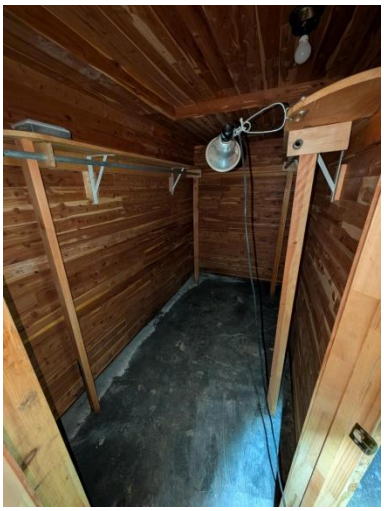
- Here are some general pics

- Ground drain is present

- Balusters recommended on steps for added safety
- Ceiling joists / Beams intact…

1. No damaged or sagging areas (all connections to sill , beam and sub floor areas intact) and no soft areas on flooring above (There were a few moldy looking spots on some joists – does not look bad or like it is spreading)…House vacant and possibly no ventilation down here for a while. Clean areas where needed

- Heat source is piping that runs along ceiling areas
- Windows have security bars (if anyone sleeping down here recommend have at least 1 window that can be used as emergency exit)
- Drain Pipes:

1. No leaks were visible while all water running above
2. There are a few areas with some stains and/or old plugs and possibly areas ready to leak (Monitor or Evaluate further for repair/sealant)....

(By sewer pit – base of pipe small cracks) and (same area some rusty piping that can possibly be helped with proper paint material)
(On rear wall areas base of 1 pipe stained)

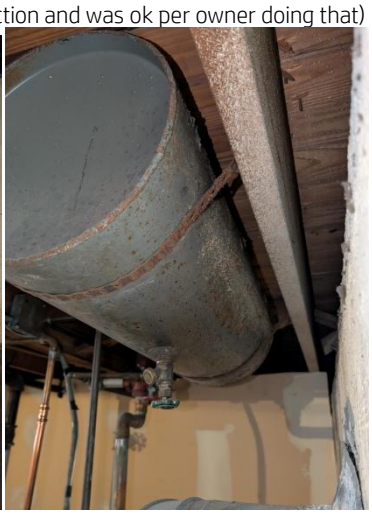
1. Water heater (2024) – check if any active warranty still available
2. Boiler ok (approx 20-25 years old)

(Expansion tank above unit is older/rusty)—Might need replacing soon
(Thermostat was shut off after inspection and was ok per owner doing that)
